## Geotechnical Evaluation of Subgrade Soil on the Frans Kasaipo Road in Tosa Urban Village

### ABSTRACT

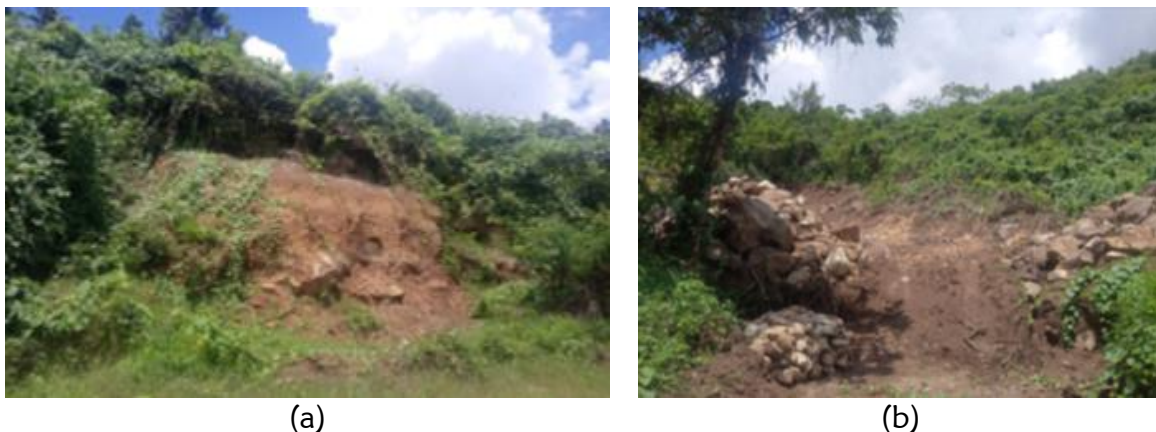
Figure 1. Locations of sample collection at site 1 (a) and site 2 (b)

Soil sampling was performed at three representative locations along the road section in Tosa Urban Village. These locations were selected based on field observations of slope geometry, signs of soil instability, and accessibility. Sampling Point 1 was located in RT 01 RW 01, Sampling Point 2 was also situated in RT 01 RW 01 at a different segment of the road, and Sampling Point 3 was located in RT 04 RW 02. The spatial distribution

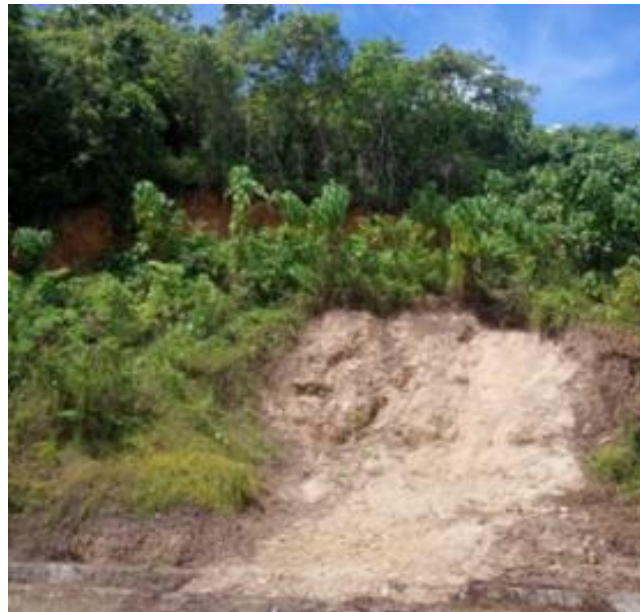
Figure 2. Location of the third sample collection
